UNDERWATER FACILITIES INSPECTIONS & ASSESSMENTS

NORFOLK NAVAL SHIPYARD
PORTSMOUTH, VIRGINIA

FPO-1-81(19) AUGUST 1981

OCEAN ENGINEERING AND CONSTRUCTION PROJECT OFFICE
CHESAPEAKE DIVISION
NAVAL FACILITIES ENGINEERING COMMAND
WASHINGTON, D.C. 20374

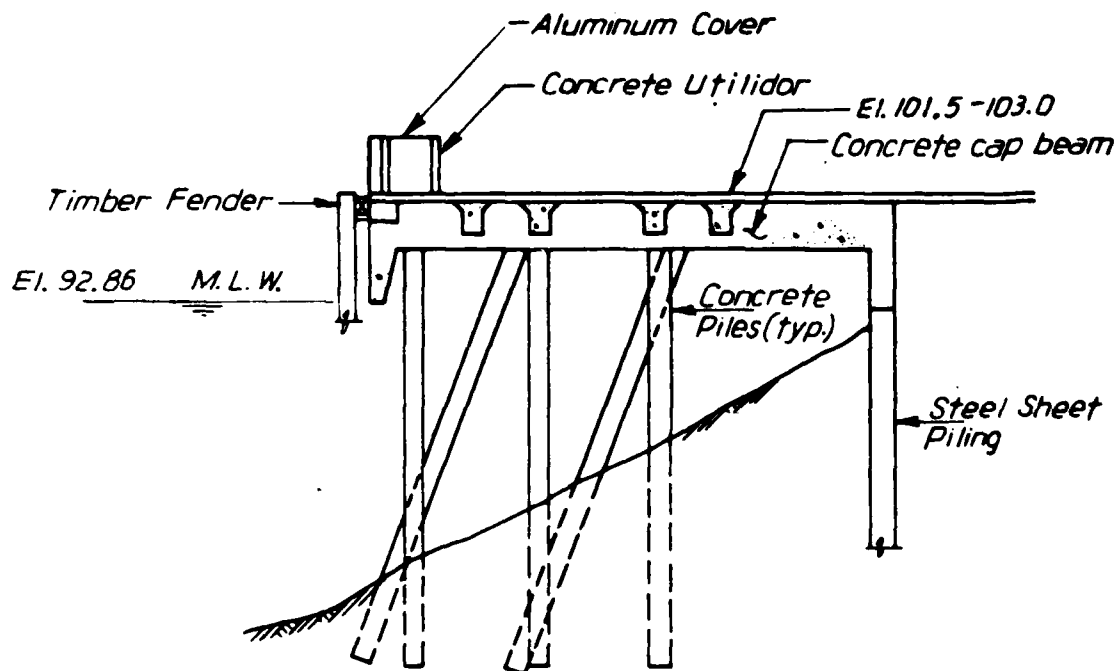
FIGURE 7 TYPICAL SECTION - BERTHS 3 AND 6

The steel sheet piling of the quaywalls at Berths 3 and 6 generally are in good condition. Except as described below, there is no visual evidence of significant material deterioration due to corrosion. Refer to Photographs 1 and 2 following this page for typical conditions above and below Mean Low Water.

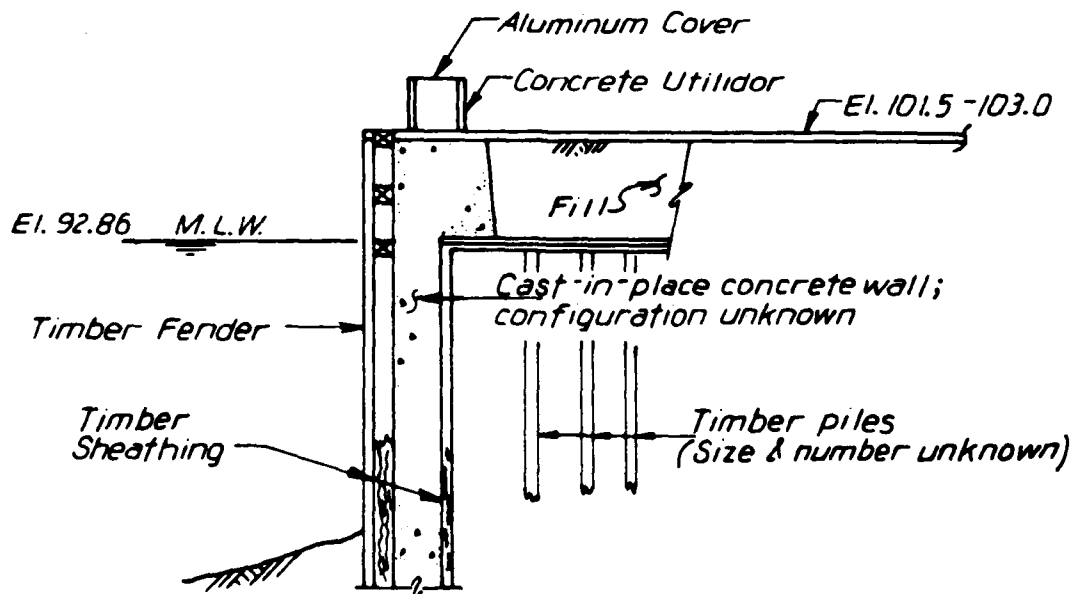
FIGURE 8 TYPICAL SECTION - BERTHS 4 AND 5

The concrete wall sections along Berths 4 and 5 and at the west end of the slip are in fair condition. Although there are many surface defects, there is no evidence of actively progressing distress. Near the tidal zone there are many areas of

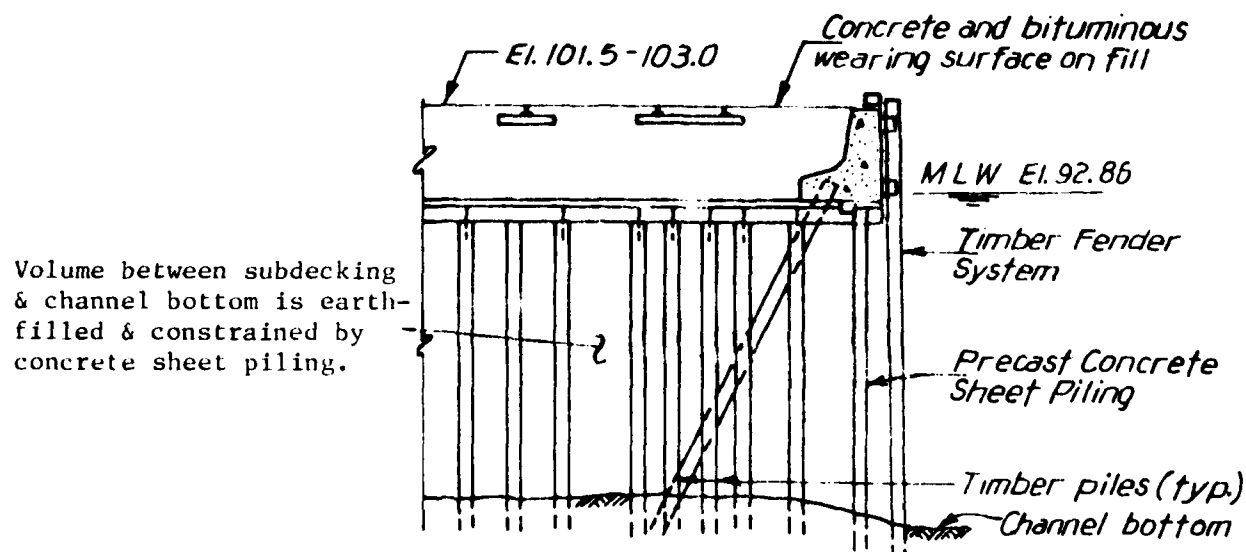
FIGURE 9 TYPICAL PARTIAL SECTION - PIERS 3, 4, 5., AND 6

Refer to Figure 6 on Page 14 and Figure 9 below for the configuration of Piers 3, 4, 5 and 6. Since the area under the piers is inaccessible and available pier drawings are poor, the exact nature of the deck load distribution is unclear. These piers were built with timber bearing piles which are enclosed in concrete sheet piling around the perimeter of each pier. The only drawings which could be obtained were very old (as far back as 1917) and appeared to indicate the cross section shown in Figures 6 and 9. Public Works personnel assured the inspection team that the area under each pier and between the concrete sheet piling was completely filled with soil so that all of the timber bearing piles are buried in fill.
